## Walkover Survey for Millmoor Rig OHMP - March 2025

**March 2025**

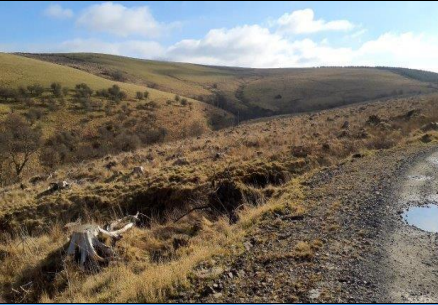
No	Grid	Note	Photo 1	Photo 2
1	NT 5973 0 0754 4	End of SSSI. Small burns have existing scrub (birch and willow) in narrow corridors. Could be reinforced and widened if get permission.

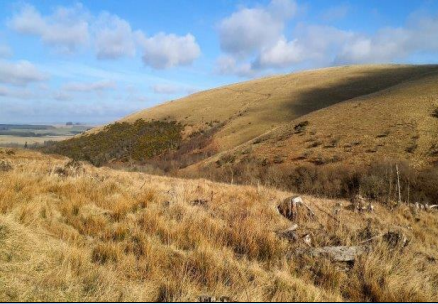
2	NT 5973 0 0754 4	View of SSSI.

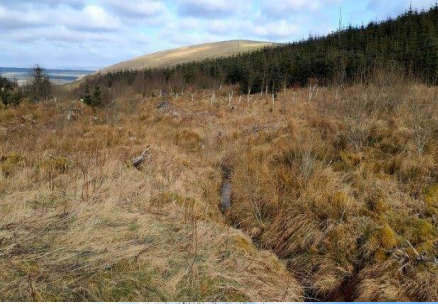
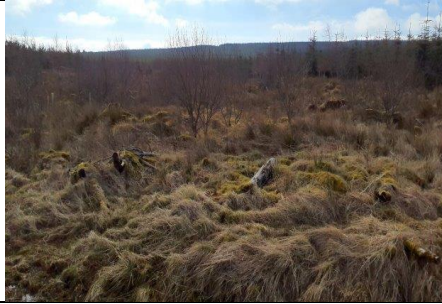
3	NT 6030 6 0723 0	Recent native broadleaved planting along watercourse. Willow, birch and beech. Could remove invasive sitka.

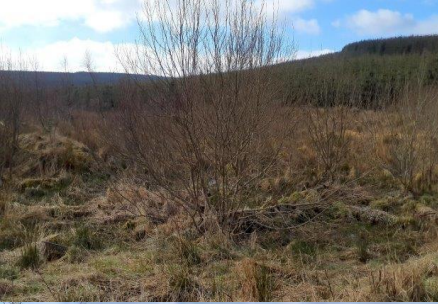
4	NT 6033 4 0724 1	Potential for creating pools in this area of rough neutral grassland (MG9).

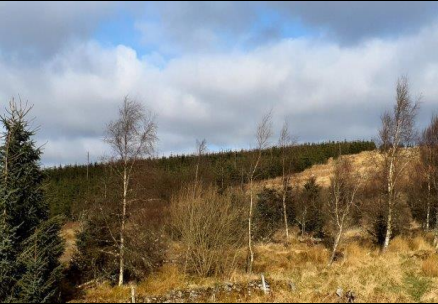
No	Grid	Note	Photo 1	Photo 2
6	NT 6071 5 0722 0	View of some remaining standing dead wood in coniferous plantation. Seems to be all of non-native coniferous dead wood. 13 stems seen.

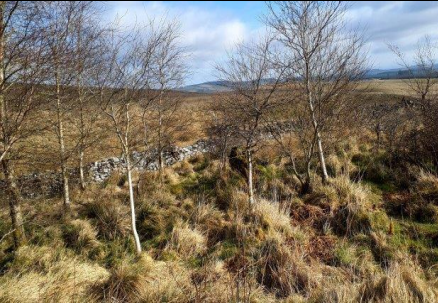
7	NT 6072 4 0722 5	Small patches of planted birch along stone walls. Good for common songbirds. Reinforcing and enlarging would help bring in additional species. It was currently 5m x 30m in size.

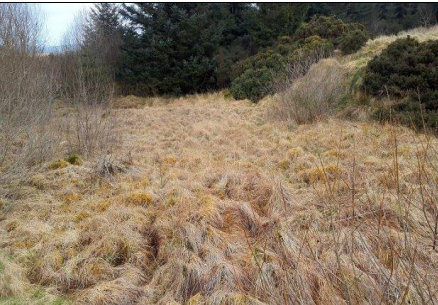
8	NT 6086 3 0684 5	Ideal flat location for a pool

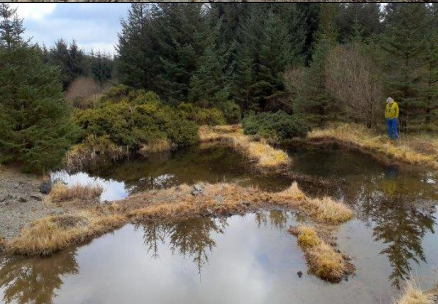
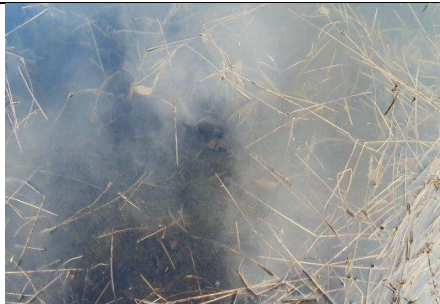
10	NT 6090 4 0645 1	Some pools exist, with frogs and toads breeding, bulrush, pond weed. Pool was surrounded by gorse and sitka, or bare ground. Could be planted.

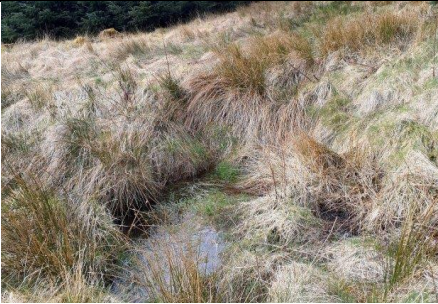
No	Grid	Note	Photo 1	Photo 2
12	NT 6108 2 0620 1	Pool could be created here, widened and deepen the existing very small puddle. The surrounding marshy grassland could have willow planted in to extend native woodland.

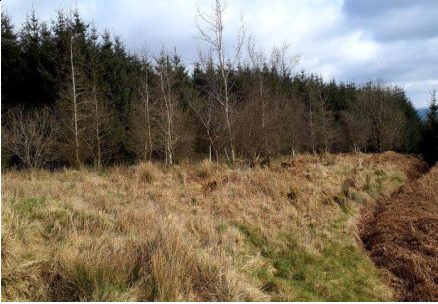
13	NT 6108 8 0619 8	Frequent patches of planted native trees. These are good for common birds. Just tubes used. Demonstrates success. Could double the size of these patches, by planting more native broadleaved species.

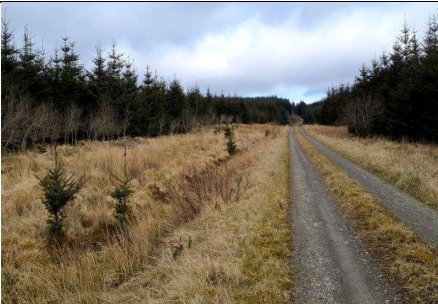
14	NT 6114 5 0599 2	This marshy grassland (species poor), could be enhanced through planting more willow and birch.

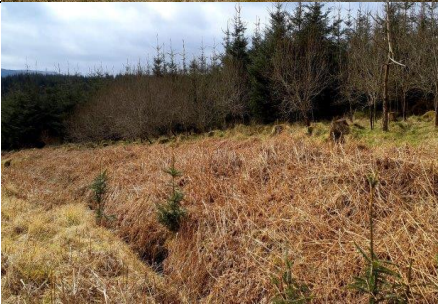
15	NT 6120 0 0568 9	Thick patches of bracken here. These could be planted with willow and birch which would help to control the bracken. Remove sitka.

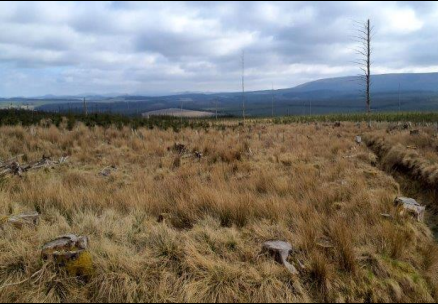
No	Grid	Note	Photo 1	Photo 2
17	NT 6150 2 0629 0	Suitable pool creation location. Recent native planting nearby.

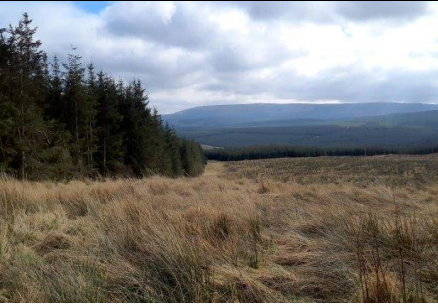
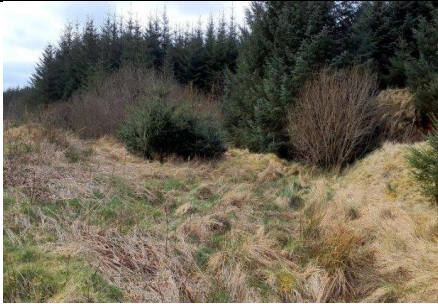
18	NT 6152 5 0664 8	Site is largely non-native coniferous plantation of varying age. The track sides and rides are largely characterised by species poor marshy grassland or neutral grassland. Willow and birch are common in small patches. These could be enlarged and reinforced.

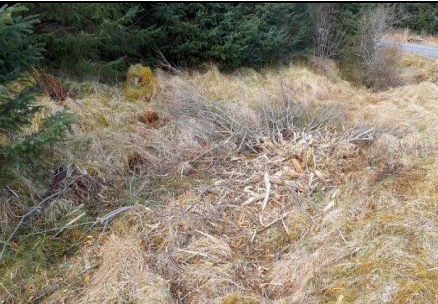
19	NT 6145 0 0700 8	Need to consider stand-off distance for willow due to existing management clearance of willow close to track edge.

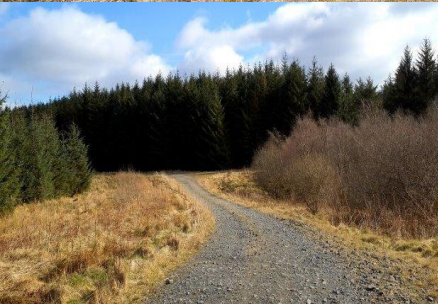
20	NT 6179 1 0698 0	Patch of historically planted broadleaved wood in triangle surrounded by forest track. A pond to the left of the photo would be suitable in an area of soft rush.

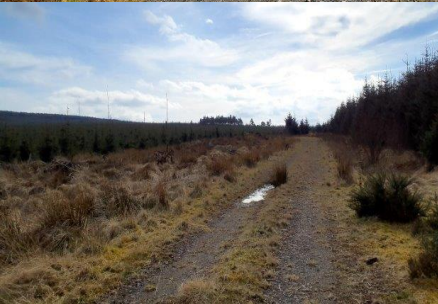
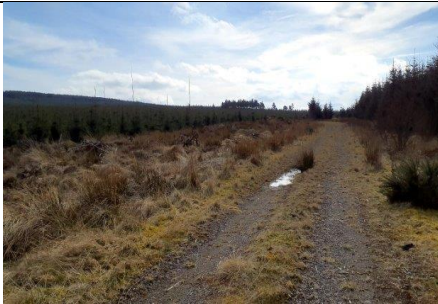
21	NT 6340 7 0615 8	Largely non-native conifer plantation with little to no ecological value. Rides and track sides largely of neutral grassland (MG9) or marshy grassland (MG10). Occasional patches of M25. Pool would add ecological value. Planting native trees would also add ecological value,

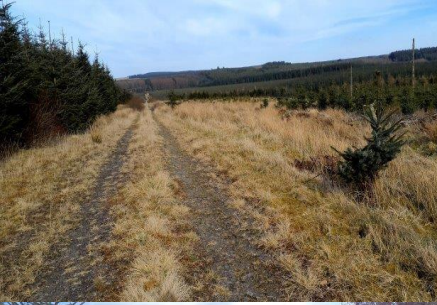
24	NT 6355 9 0632 2	Link willow along track sides to make a nature network.

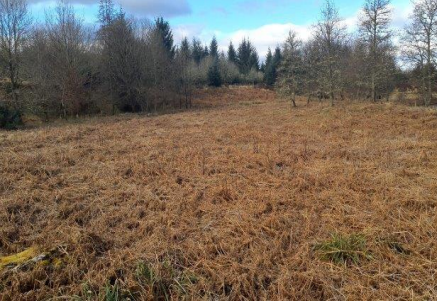
26	NT 6561 2 0753 4	Flat area around existing pool to right of track as you drive into the site. Could have a pool added. Bracken dominated at the moment. Plant with alder and willow around new pool may help to lessen the dominance of bracken.

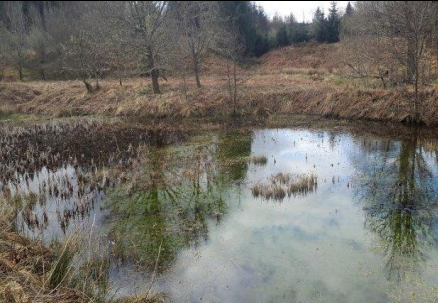
No	Grid	Note	Photo 1	Photo 2
27	NT 6553 8 0756 6	Pool has high ecological value. It is filled with toads and frogs breeding. Noisy and bubbling with activity. There were deep areas, as well as shallow areas of the pool which provides different niches for a variety of species. Bulrush and sedges present.

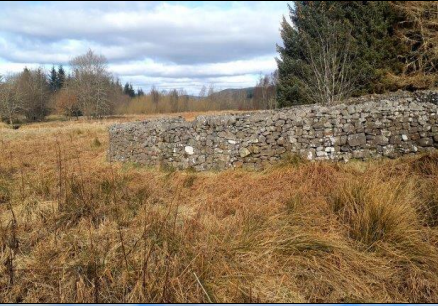
Several photos on camera.
28	NT 6553 6 0756 8	Relatively open areas with dry stone wall and bracken. Could add hibernacula as well as stands of native broadleaved species.

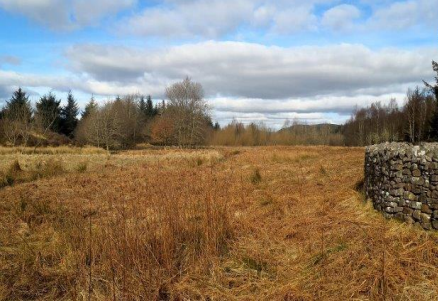
29	NT 6552 6 0756 8	Already existing planted patches of alder and birch. These look to be more than 15 years old. Could add additional patches to create a variation in age and size.

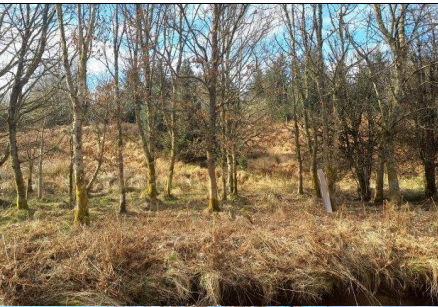
30	NT 6552 3 0755 0	Birch, beech, alder, planted c. 20 years ago. Demonstrates success.

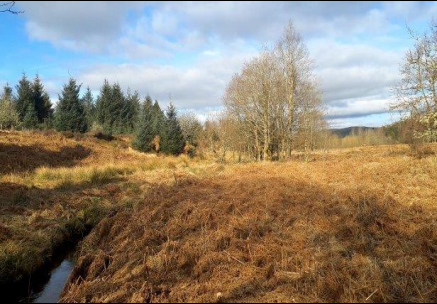
33	NT 6555 8 0751 6	Remove sitka encroachment.

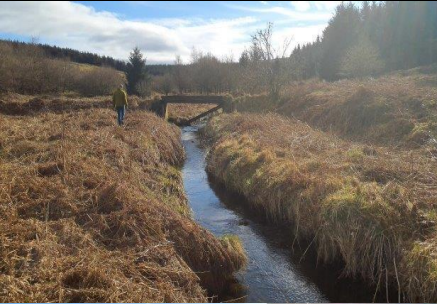
34	NT 6557 9 0751 4	Could put a line of trees along the burn.

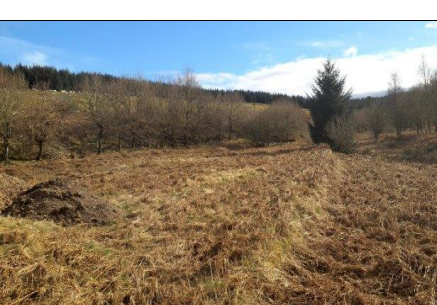
36	NT 6561 0 0751 2	Add pool here.

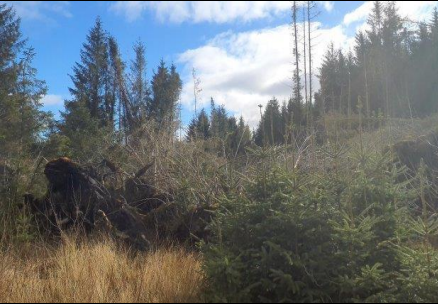
No	Grid	Note	Photo 1	Photo 2
38	NT 6557 2 0742 2	Large area of windthrow. This could be cleared and planted with native broadleaf species to increase the patch size of semi natural habitat.

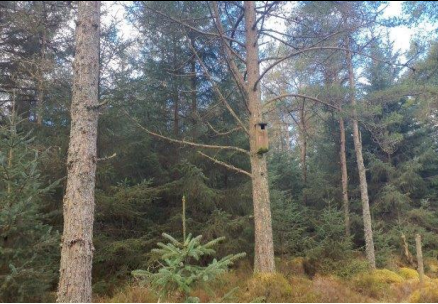
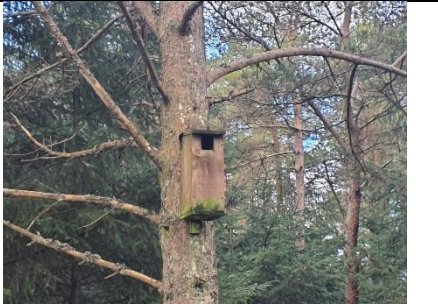
39	NT 6530 8 0696 3	Owl box here.

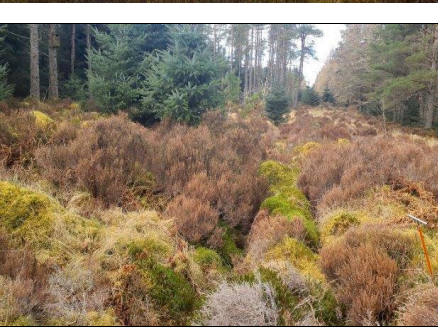
41	NT 6532 2 0696 5	There is some evidence of a ditch, but no peatland restoration opportunity.

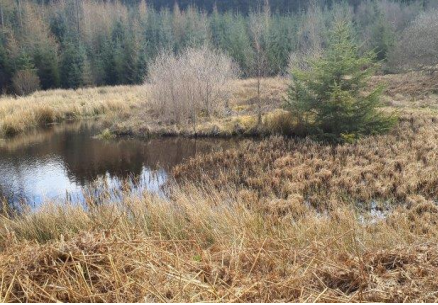
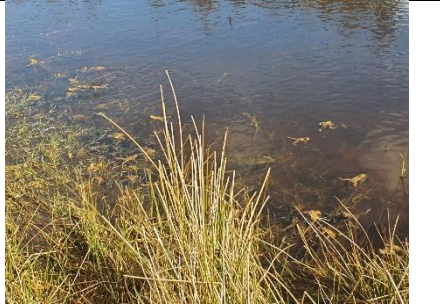
48	NT 6484 6 0630 8	High quality existing pool. Frogs and toads breeding. Remove sitka from island. Bottle sedge here.

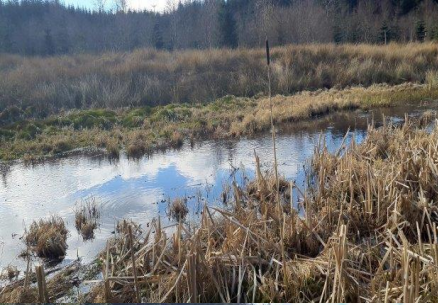
54	NT 6458 3 0679 7	The remaining section of pool/oxbow is filled with toads and bulrush.

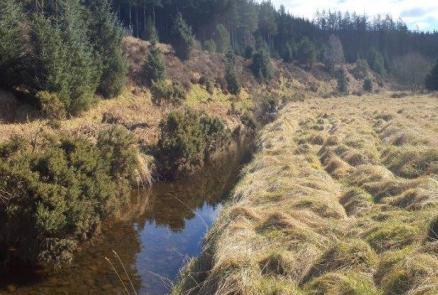
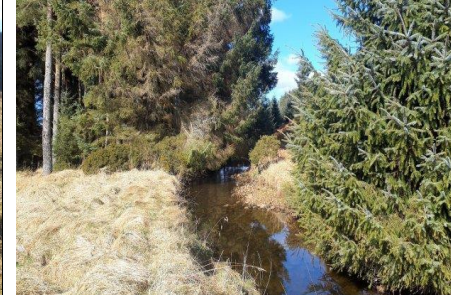
55	NT 6468 6 0683 2	This section of the burn could have sitka removed from edge and be planted with native broadleaved trees.

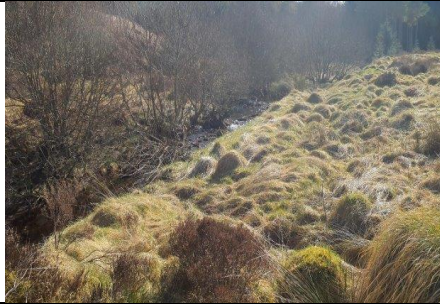
57	NT 6478 3 0669 6	Riparian planting would link existing stands of alder and willow.

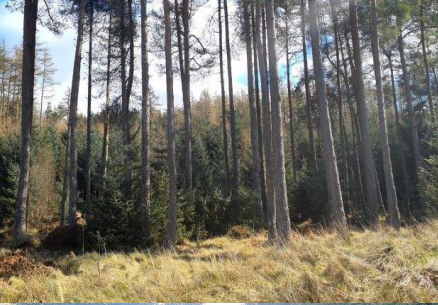
60	NT 6480 2 0659 4	Stand of Scots pine with sitka below. Remove the sitka.

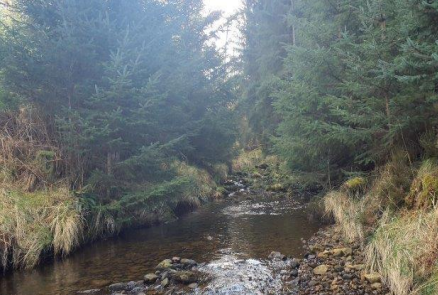
61	NT 6483 8 0659 3	Sitka dense on side of burn. This should be removed and native broadleaved planted.

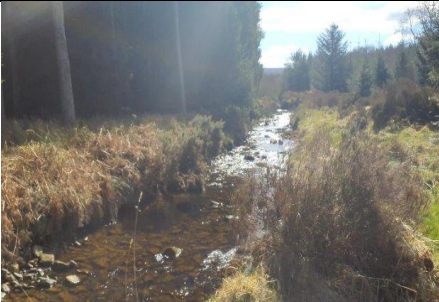
No	Grid	Note	Photo 1	Photo 2
62	NT 6478 8 0649 0	Sitka dense on side of burn. This should be removed and native broadleaved planted.

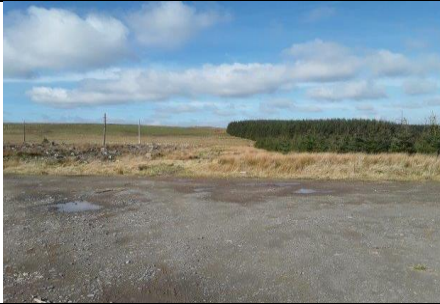
No	Grid	Note	Photo 1	Photo 2
68	NT 6218 8 0808 3	Example location for owl box.

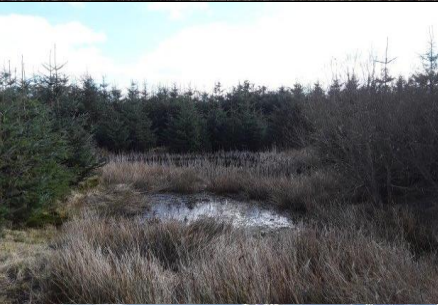
70	NT 6245 6 0819 2	Existing pools with bulrushes soft rush, willows. Remove sitka.

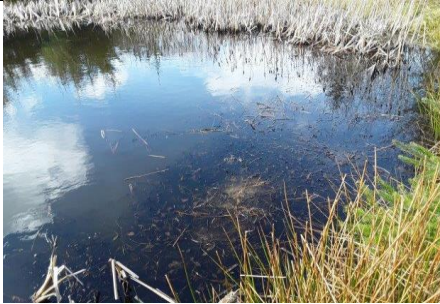
71	NT 6240 6 0812 9	The existing pool was filled with toads breeding, and frogspawn. Demonstrates that additional pools would be ideal. Frogs and toads are prey items for otters, pine martens and sometimes badgers.

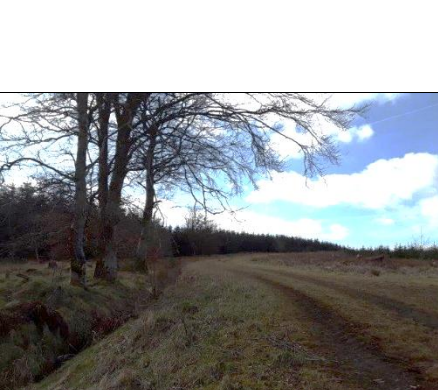
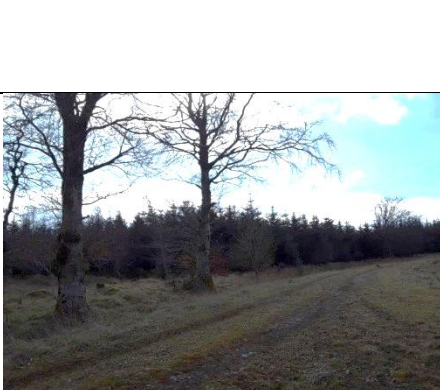
72	NT 6266 3 0849 8	Could add more trees here. There was hawthorn and beech trees. Could also add boxes for owls etc

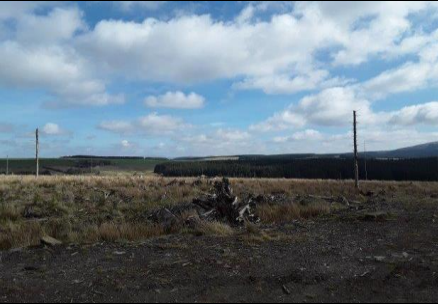
74	NT 6304 4 0811 9	Could put owl boxes on these larger standing dead wood trees.

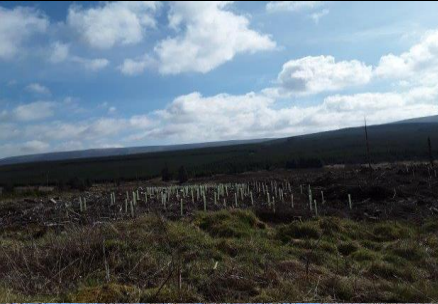
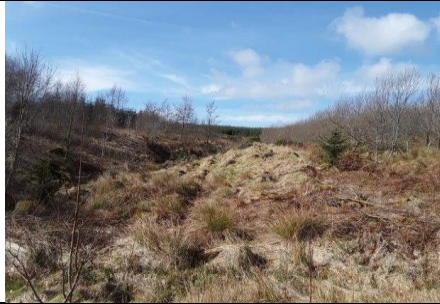
75	NT 6230 1 0656 6	Existing broadleaf planting along burn. Extending existing broadleaf wood (second photo).

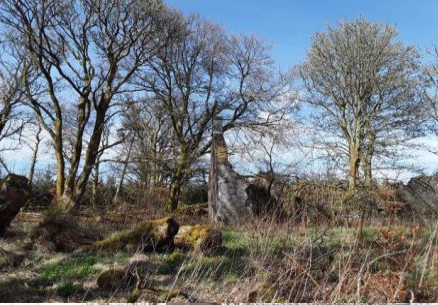
77	NT 6227 4 0650 2	Could have small bird boxes, such as redstart boxes, here and bat boxes.

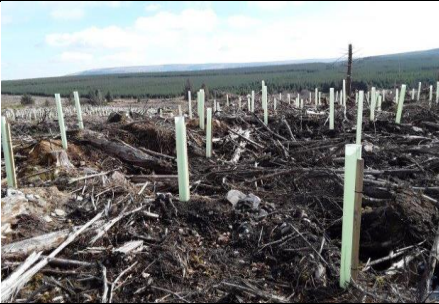
No	Grid	Note	Photo 1	Photo 2
79	NT 6230 7 0651 4	Very recently planted broadleaves in tubes. Likely planted in the last 6 months.

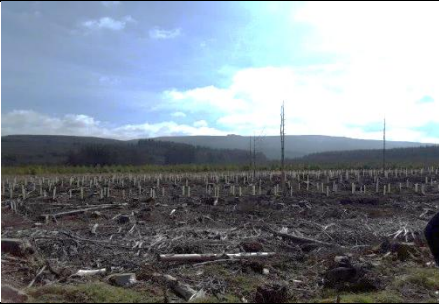
80	NT 6207 3 0598 7	Existing recent planting of native trees.

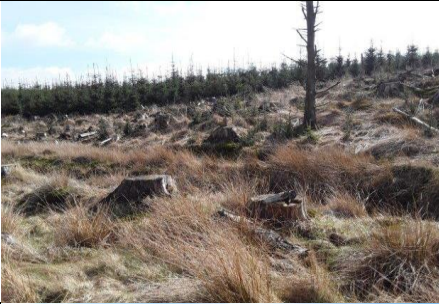
81	NT 6180 5 0561 6	No evidence of peatland habitat on marked deep peat in this section. Marshy grassland.

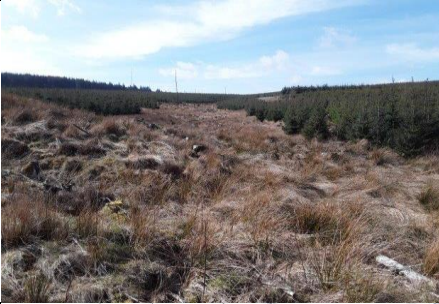
82	NT 6178 3 0559 7	Suitable for riparian planting. No peatland habitat. Its marshy grassland.

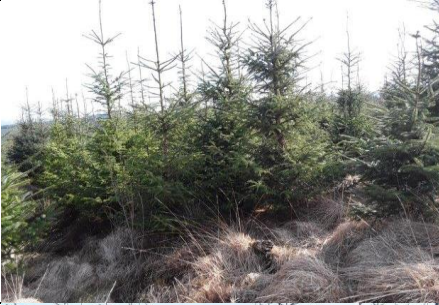
83	NT 6178 7 0555 3	There did appear to be some deep peat with sitka on. No evidence of peatland habitat remaining. Little peatland restoration opportunities.

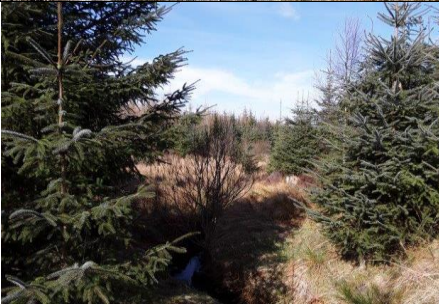
87	NT 6383 9 0614 2	Remove sitka from c.10m from edge of watercourse and plant with native broadleaf species. Some were 1-2m away from watercourse, whilst there were also some more open areas. Some willow and birch also present. Reinforce.

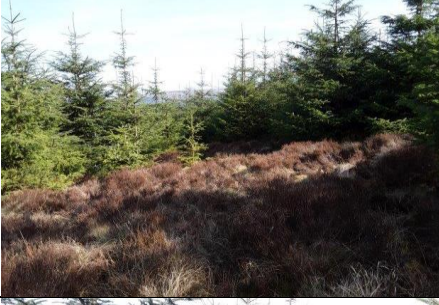
88	NT 6378 5 0529 9	Deep heather, on shallow soils. Plantation all around. No peatland restoration opportunity identified.

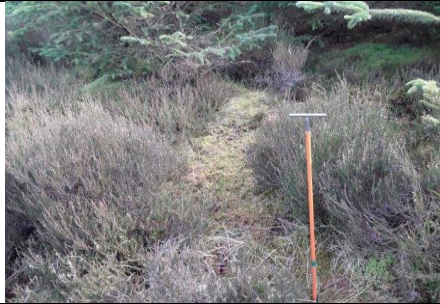
No	Grid	Note	Photo 1	Photo 2
90	NT 6366 1 0524 4	There was some patches of red bog-moss and hare's-tail cottongrass in dense heather. Appeared to be on largely shallow soils at this location.

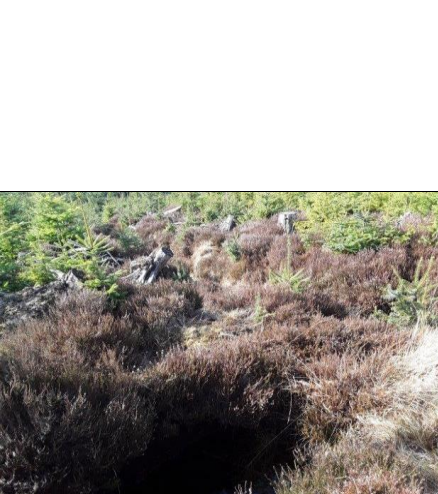
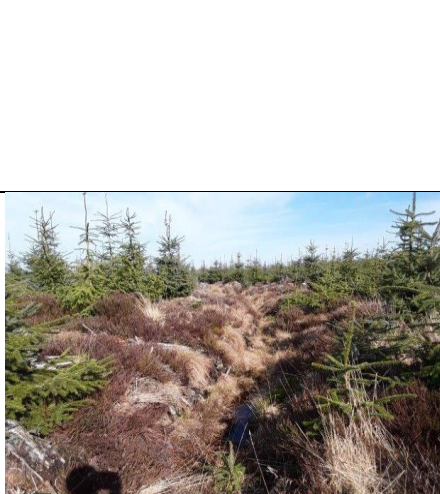
93	NT 6336 2 0572 6	Drains apparent. Some standing water 0.5m below surface. Some peatland restoration potential in localised area.

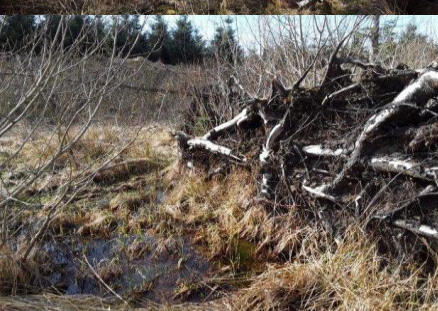
100	NT 6378 5 0765 1	Fen with some frogspawn and bottle sedge. Removed conifers.

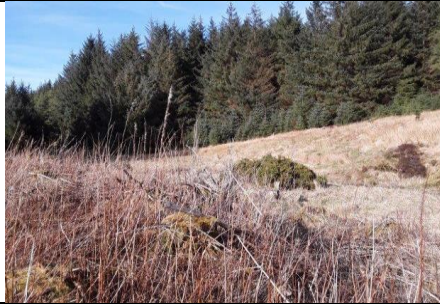
10 2	NT 6389 2 0767 3	Native planting along banks of watercourse is possible. Both sides here.

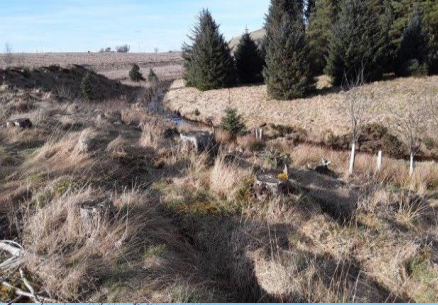
10 5	NT 6371 3 0783 0	Existing planting stops here. Could extend, although quite steep this side better on far side. Habitat was species poor marshy grasslands. Planted with alder and birch.

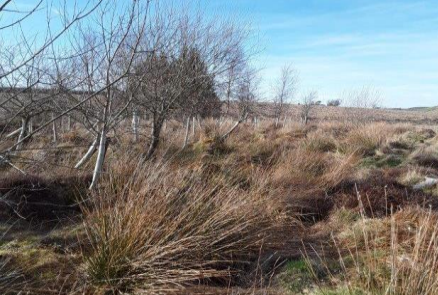
10 6	NT 6366 6 0786 1	More existing planting here. Extensive planting in large valley nearby.

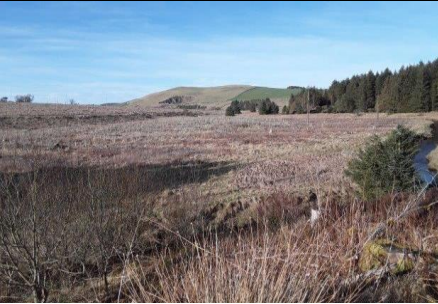
No	Grid	Note	Photo 1	Photo 2
107	NT 6364 5 0790 7	View of extensive planting around confluence of Black Burn and Jed Water. Potentially some space for more around edge, towards main watercourse, Black Burn.
