## Walkover Survey for Millmoor Rig OHMP - March 2025

**March 2025**

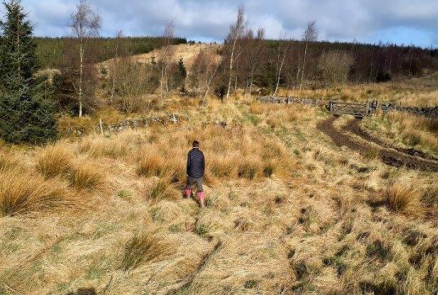
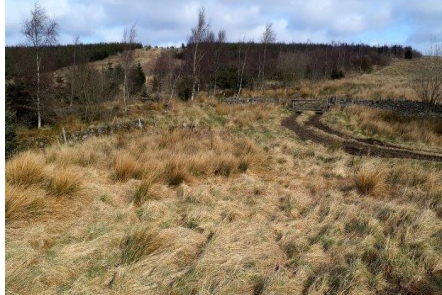
5	NT 6071 1 0721 4	Potential pool location on flat area with soft rush, Yorkshire fog and common sorrel (MG10). No standing water present. Suitable low topography.

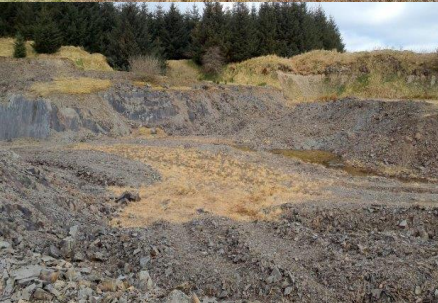
9	NT 6088 3 0644 9	Quarry, with largely bare rock and species tolerant of disturbance e.g. coltsfoot and mat grass. Could make something of pools of water.

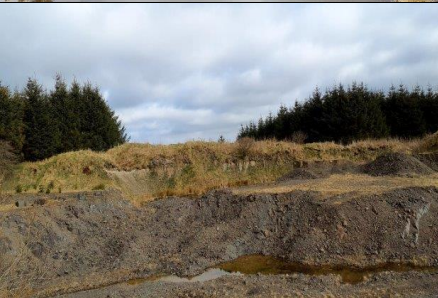
11	NT 6085 8 0644 9	Pools with bulrush and soft rush on the far side of quarry. Enhancement opportunities in the quarry if quarry not still used.

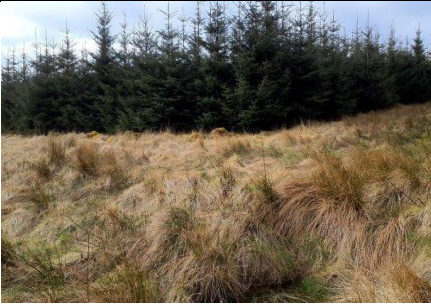
No	Grid	Note	Photo 1	Photo 2
12	NT 6108 2 0620 1	Pool could be created here, widened and deepen the existing very small puddle. The surrounding marshy grassland could have willow planted in to extend native woodland.

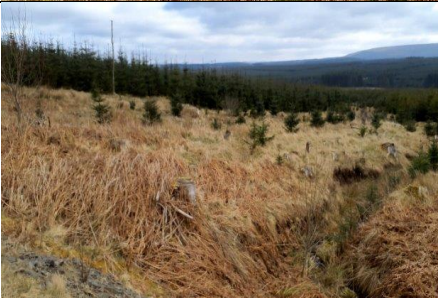
16	NT 6155 3 0573 2	Open area of marshy/neutral grassland. Removal of sitka and reinforce area with some native species. Standing deadwood present.

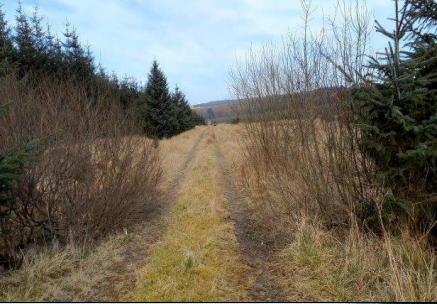
No	Grid	Note	Photo 1	Photo 2
		particularly if creating links.		
22	NT 6347 6 0623 1	Link willow along track sides to make a nature network.

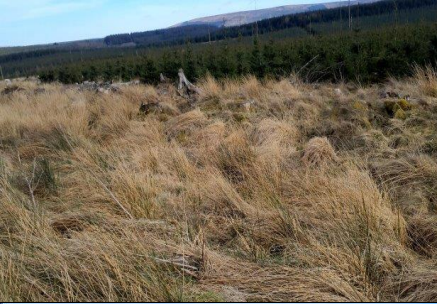
23	NT 6349 3 0625 1	Could widen ditch and create pool in this area of soft rush.

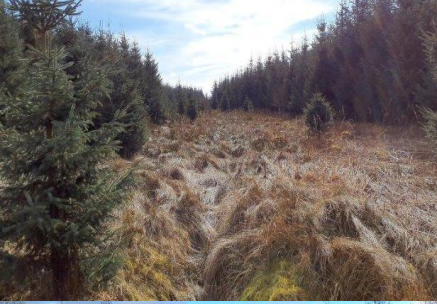
25	NT 6346 6 0705 8	Riparian planting opportunity. 20m wide ride, with watercourse in middle could have native trees or scrub planted.

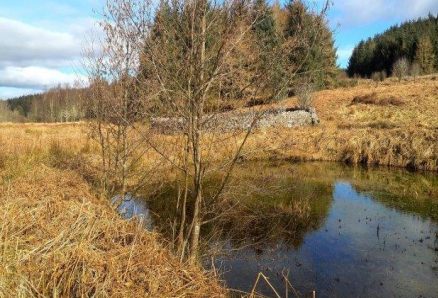
31	NT 6552 5 0755 2	Example of alder at the edge of existing pool. Alder should be planted in suitable locations around newly created pools.

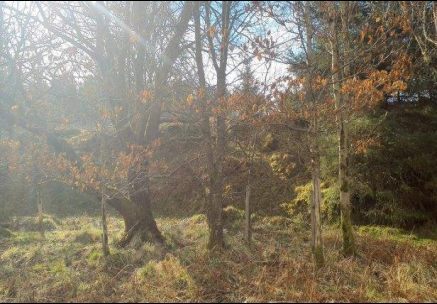
No	Grid	Note	Photo 1	Photo 2
32	NT 6555 5 0751 5	Some of the larger trees would be suitable for owl boxes.

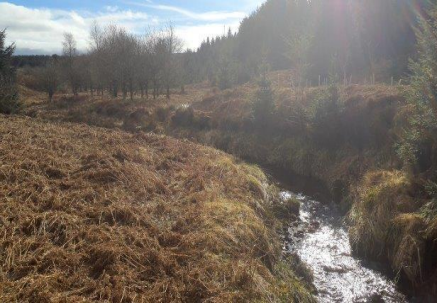
35	NT 6561 2 0751 1	A pool could also be created on the left side of the track. Ecological enhancement would involve removing sitka and plant alder, birch, oak, to reinforce existing planted areas.

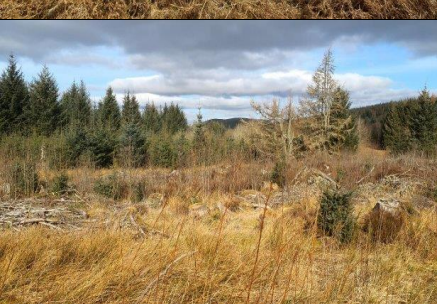
37	NT 6557 4 0744 0	Evidence of some natural regeneration of birch in this area. Sitka also regenerating.

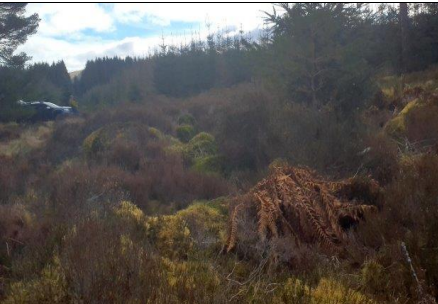
40	NT 6531 6 0697 1	Marked as M19, shallow soils but does have heather, blaeberry, and some hare's-tail cottongrass. Little to no bog moss. Could remove sitka from the ride.

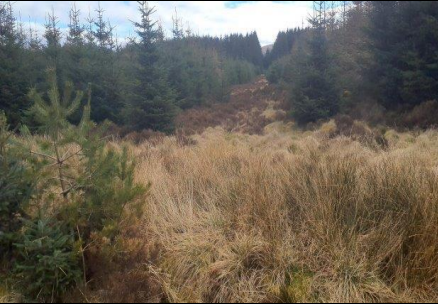
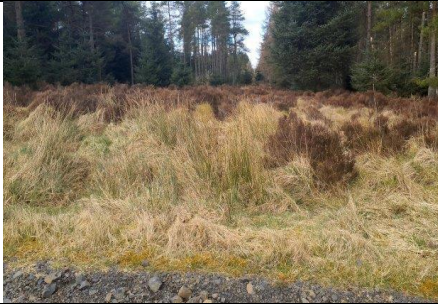
42	NT 6535 4 0694 9	Could create a pool here.

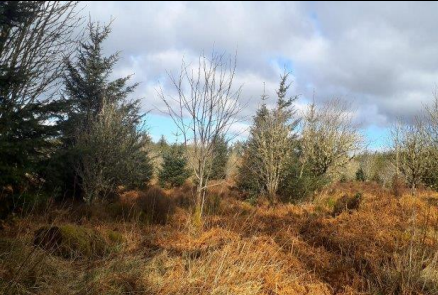
43	NT 6518 0 0672 5	Patch of birch covered in lichens with heather below. This area could have the sitka removed. Perhaps have some more trees planted.

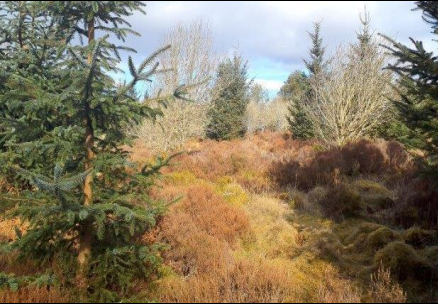
No	Grid	Note	Photo 1	Photo 2
44	NT 6517 1 0674 3	Area was dry heath (H12) with bracken, and a mix of tree species (birch, rowan). To enhance this area remove sitka and add more native species.

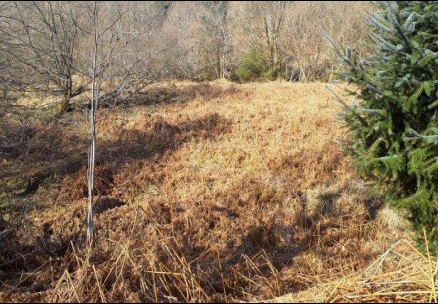
45	NT 6489 8 0617 2	Area suitable for a pool. Relatively open mixed native trees. Remove sitka and add pool.

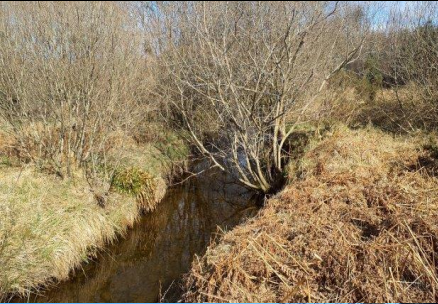
46	NT 6488 3 0620 0	Watercourse was already lined with willow and alder. This is suitable and demonstrates the type of riparian planting required.

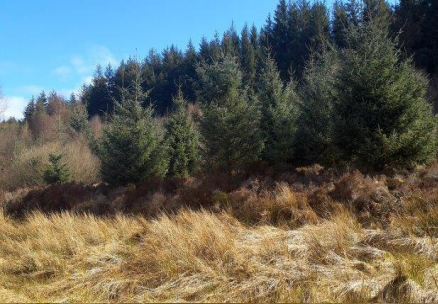
47	NT 6488 7 0623 3	Remove sitka regen from this area which is sometimes 5m tall.

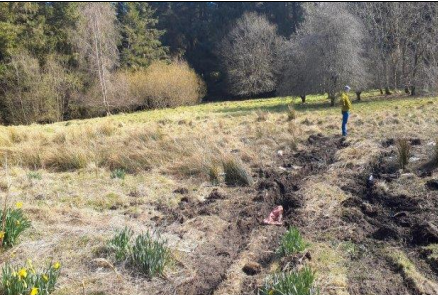
49	NT 6491 6 0598 9	Evidence of some fly-tipping here. Could clear up. Rushes area suitable for pool.

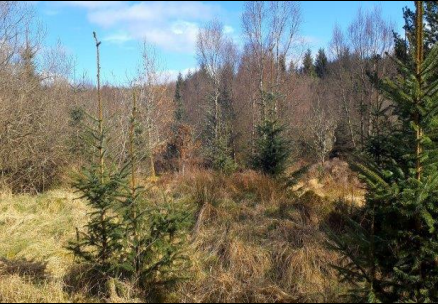
No	Grid	Note	Photo 1	Photo 2
50	NT 6471 7 0639 2	Woodland here was a mix of native species birch, rowan and alder with sitka. The main enhancement would be to remove the sitka.

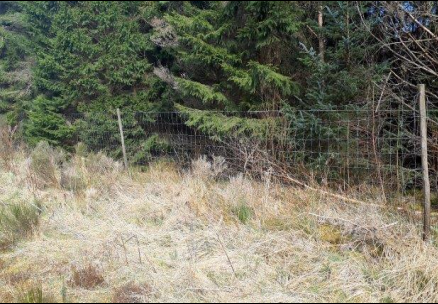
51	NT 6460 6 0655 9	There is a fence here. But not black grouse habitat. No requirement to mark.

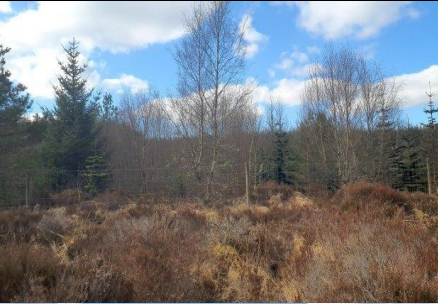
52	NT 6469 7 0670 8	The fence is around sitka plantation and areas of birch. Birch areas are dense thickets. Could remove fence into this area and allow browsing.

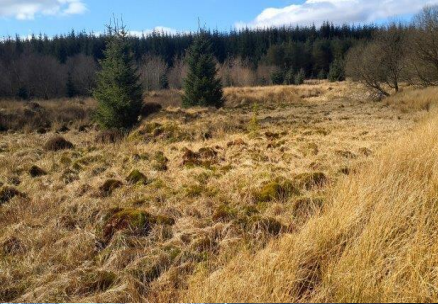
53	NT 6463 0 0679 0	Infilled pool could be re-dug. Sitka could be removed.

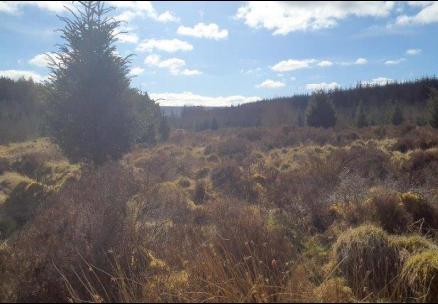
No	Grid	Note	Photo 1	Photo 2
56	NT 6473 3 0677 3	This area generally could have sitka removed and potentially planted with stands of suitable native species. However, some deep peat may be present.

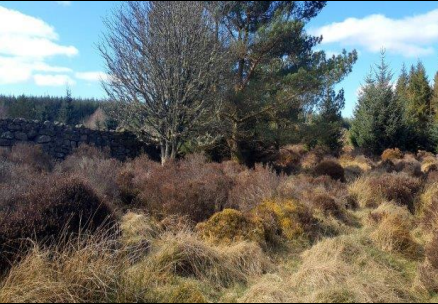
57	NT 6478 3 0669 6	Riparian planting would link existing stands of alder and willow.

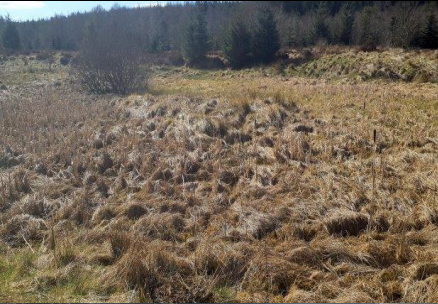
58	NT 6478 2 0664 4	Infilled pool. There was a little open water remaining. Bulrush and purple moor-grass infilled. A little water around the willow. Re dig this area to create a pool.

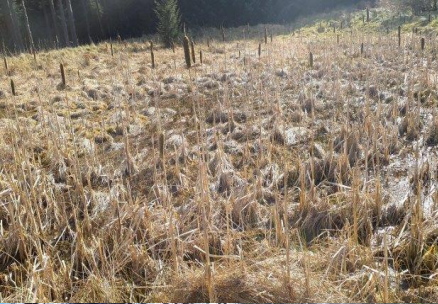
59	NT 6478 7 0658 5	A third infilled pool. There was a very small amount of open water which was filled with breeding toads. Needs some deep and shallow areas. Infilled pool could be re-dug.

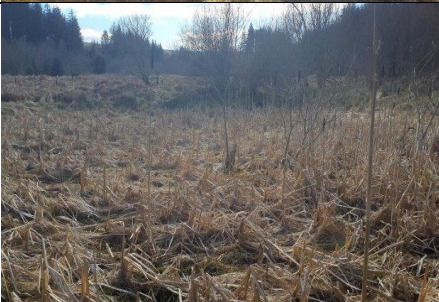
63	NT 6482 5 0640 6	Another largely infill pool with bulrush. Could be dug and profiled.

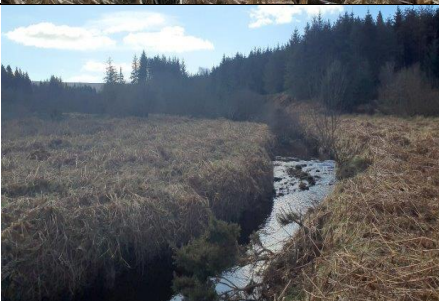
64	NT 6484 1 0636 6	Open area of bracken. Scattered birch, alder and willow. Remove sitka and plant riparian woodland and stands of native Broadleaved. Could add hibernacula.

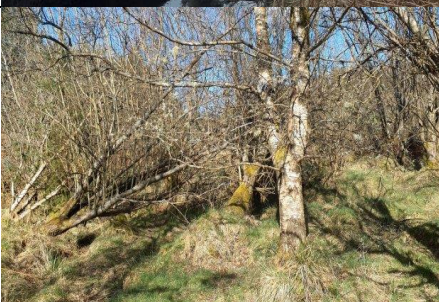
65	NT 6483 7 0622 7	Example of existing wet woodland, birch, alder and willow.

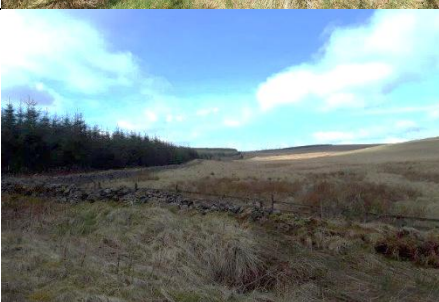
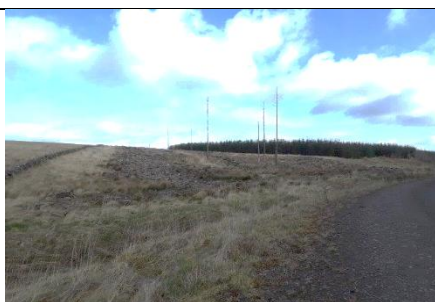
66	NT 6197 6 0735 3	Could join up two broadleaved patches, through native tree planting along dry stone wall and along track.

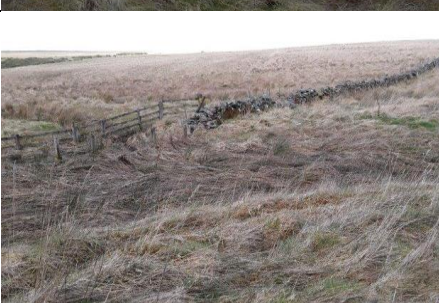
67	NT 6192 4 0736 0	Could create a pool here in flat area.

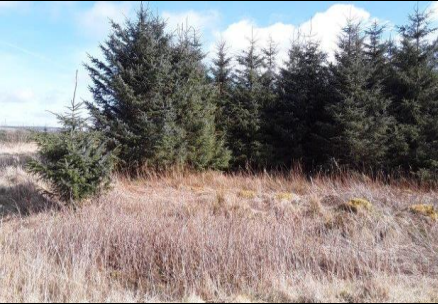
No	Grid	Note	Photo 1	Photo 2
68	NT 6218 8 0808 3	Example location for owl box.

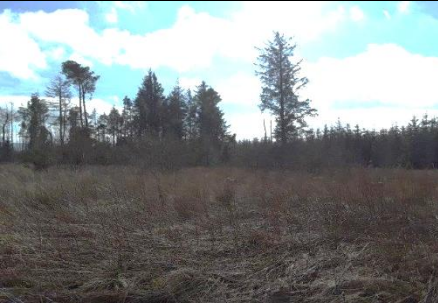
69	NT 6238 2 0810 6	Open areas here could be planted with native broadleaved species to reinforce the existing willow.

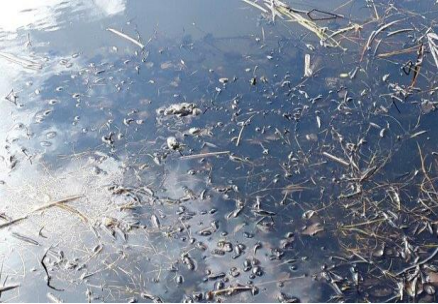
71	NT 6240 6 0812 9	The existing pool was filled with toads breeding, and frogspawn. Demonstrates that additional pools would be ideal. Frogs and toads are prey items for otters, pine martens and sometimes badgers.

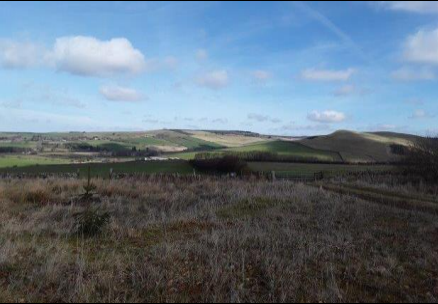
No	Grid	Note	Photo 1	Photo 2
73	NT 6266 2 0849 7	Could link in with these hedgerows of sloe and hawthorn.

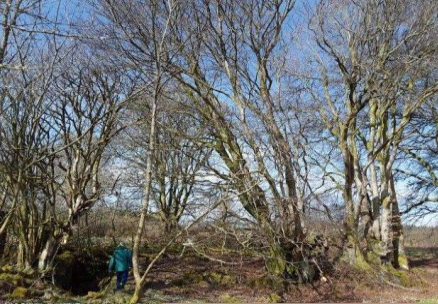
76	NT 6229 1 0646 2	Existing beech woodland. Could add bird and bat boxes.

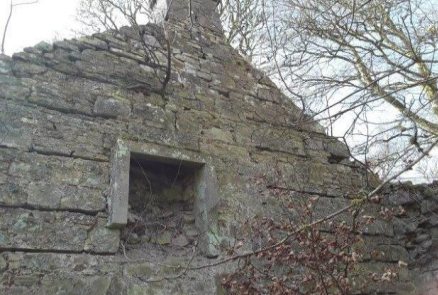
78	NT 6223 7 0647 6	Could add owl or bat boxes to side of house.

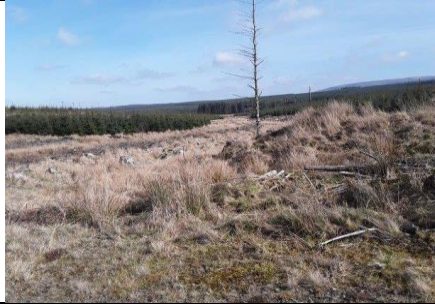
82	NT 6178 3 0559 7	Suitable for riparian planting. No peatland habitat. Its marshy grassland.

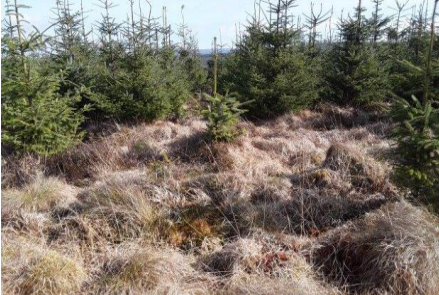
84	NT 6178 4 0553 2	There was some bog moss and heather with hare's-tail cottongrass with recently planted sitka. Restoration would require felling.

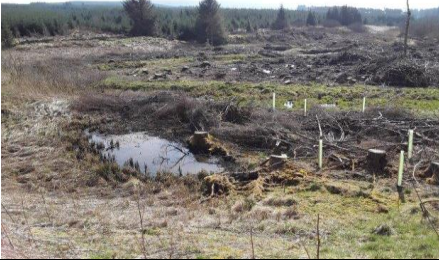
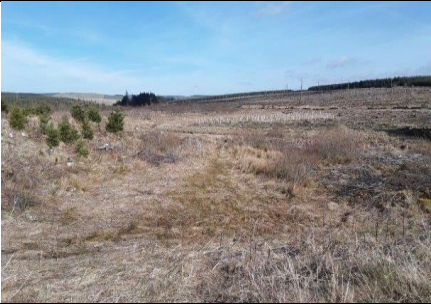
No	Grid	Note	Photo 1	Photo 2
85	NT 6258 3 0654 4	Pool could be dug out and made permanent. There was existing planting which could be reinforced.

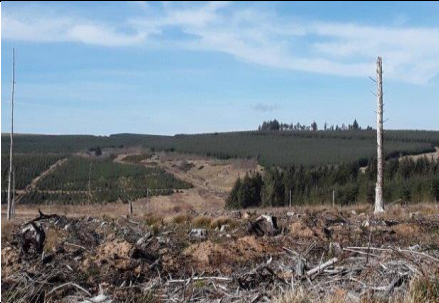
86	NT 6317 2 0696 4	Potential for riparian planting along valley of Pedens Cleuch.

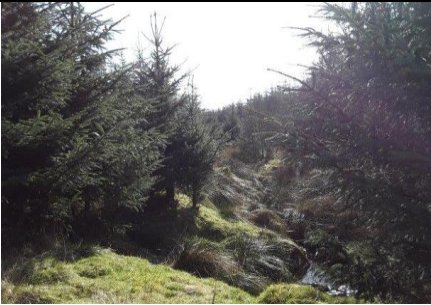
87	NT 6383 9 0614 2	Remove sitka from c.10m from edge of watercourse and plant with native broadleaf species. Some were 1-2m away from watercourse, whilst there were also some more open areas. Some willow and birch also present. Reinforce.

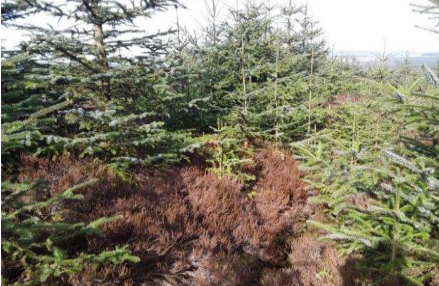
89	NT 6353 5 0521 3	Deep peat must be in pockets. Deep heather over what appeared to be largely shallow soils. Thick sitka plantation. Little peatland restoration opportunity.

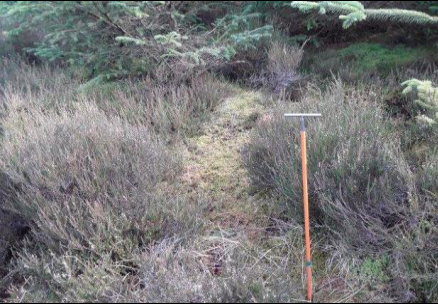
No	Grid	Note	Photo 1	Photo 2
90	NT 6366 1 0524 4	There was some patches of red bog-moss and hare's-tail cottongrass in dense heather. Appeared to be on largely shallow soils at this location.

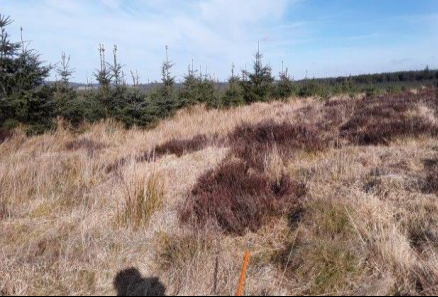
91	NT 6358 8 0569 5	Small patch of perhaps just over 50cm deep with purple moor-grass M25a. Surrounded by plantation. Little peatland restoration potential.

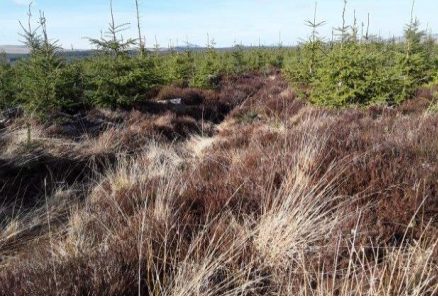
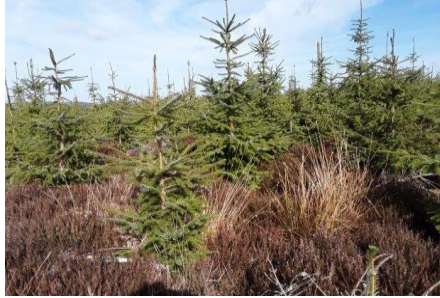
92	NT 6336 6 0570 8	Some forest to bog restoration possible here. Felled plantation with c. 2m tall sitka growing on top. Heather, purple moor-grass and rushes with a little red bog-moss and hare's-tail cottongrass. Occasional ditches were present and a farrow systems evident.

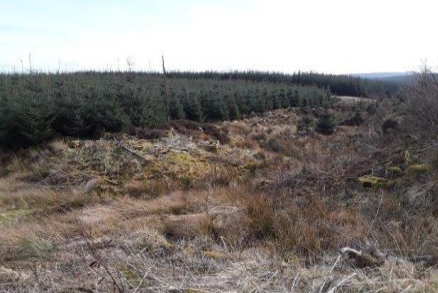
94	NT 6387 1 0670 1	Existing broadleaved planting up streamside.

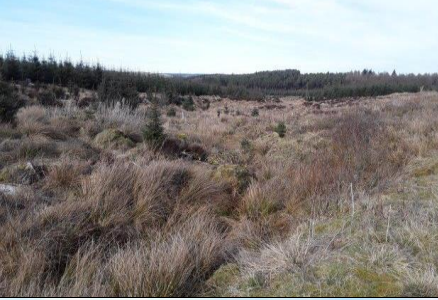
No	Grid	Note	Photo 1	Photo 2
95	NT 6390 2 0674 1	Existing broadleaved planting downstream of here along watercourse.

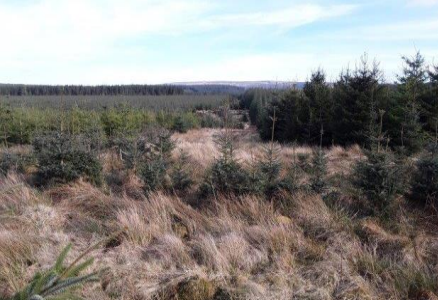
96	NT 6390 2 0674 1	Potential pool creation location on flat marshy grassland.

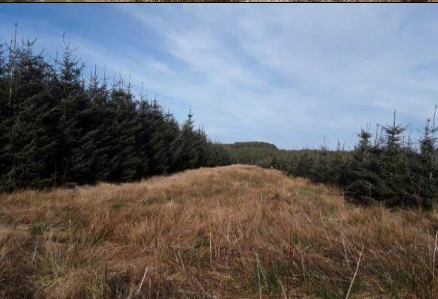
97	NT 6360 8 0696 1	Broadleaved planting opportunity below track, down ride to watercourse.

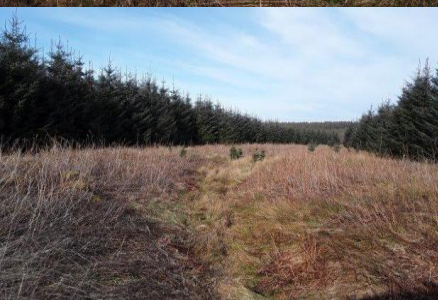
98	NT 6346 6 0705 8	Broadleaved planting along riparian corridor below track.

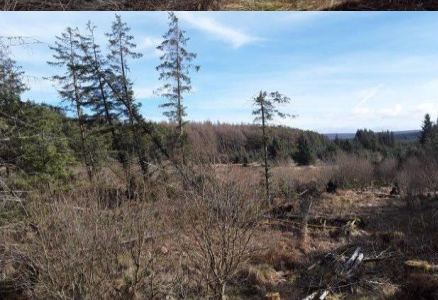
99	NT 6376 6 0767 3	View of watercourse valley. Some willow and alder already present. Some recent planting. Could remove non-native conifers and plant more native species.

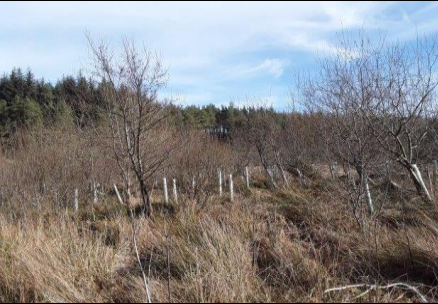
No	Grid	Note	Photo 1	Photo 2
10 1	NT 6381 3 0765 8	Existing patches of alder and willow, including planted areas. These could be reinforced.

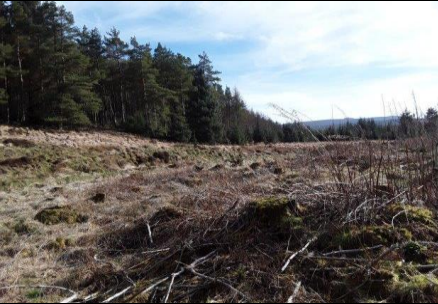
10 2	NT 6389 2 0767 3	Native planting along banks of watercourse is possible. Both sides here.

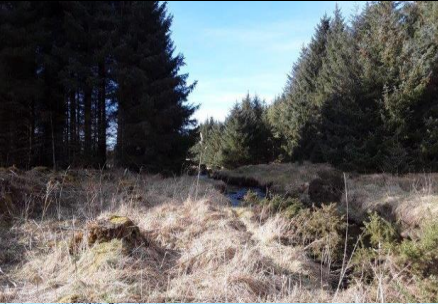
10 3	NT 6388 7 0771 2	Planting possible here and clearing from edge of watercourse

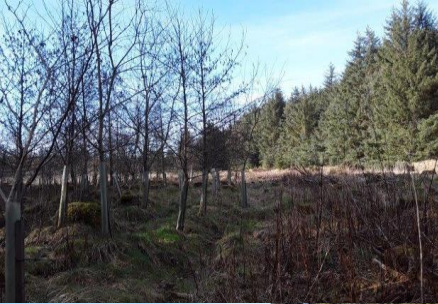
10 4	NT 6383 9 0774 7	Existing planting here. Up to 5m tall. Alder.

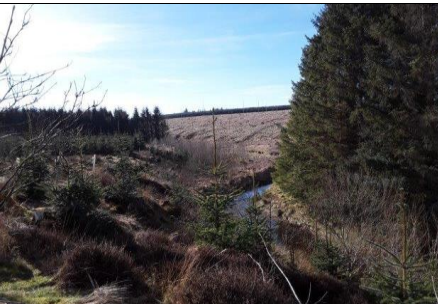
108	NT 6362 9 0790 2	Extensive recently planted native species along the valley of Jed Water.

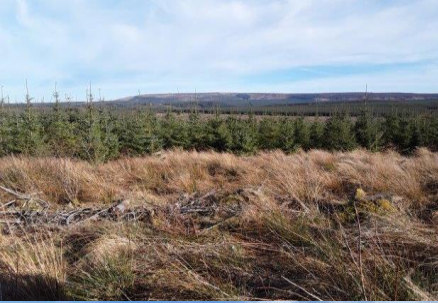
109	NT 6245 5 0721 7	No evidence of peatland habitat on area identified as deep peat. Rushes and marshy grassland with sitka plantation.

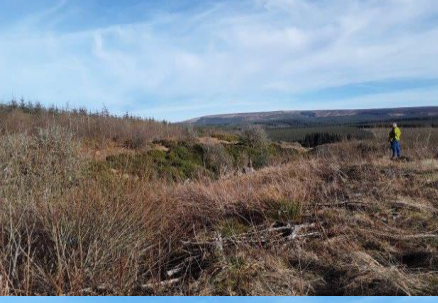
110	NT 6250 3 0756 2	Native species planting potential on valley here. Some planting already present. Gorse in valley.

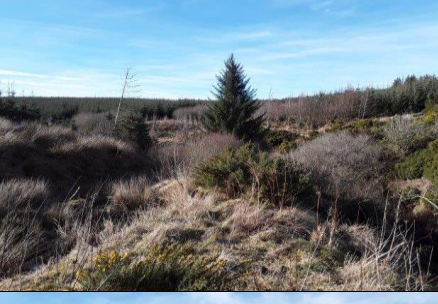
111	NT 6249 9 0757 6	Another view of potential area for planting. This would be reinforcing the existing woodland.

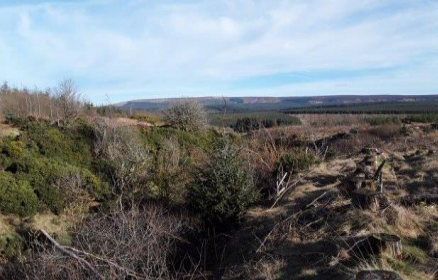
112	NT 6252 6 0755 3	Some existing woodland and gorse and recent native planting. Some opportunity for planting to reinforce corridor. Already a mix of ages. Could add
